Department of Water Resources

BULLETIN No. 183-2

RIVERSIDE COUNTY FLOOD HAZARD INVESTIGATION— MURRIETA CREEK

MAY 1975

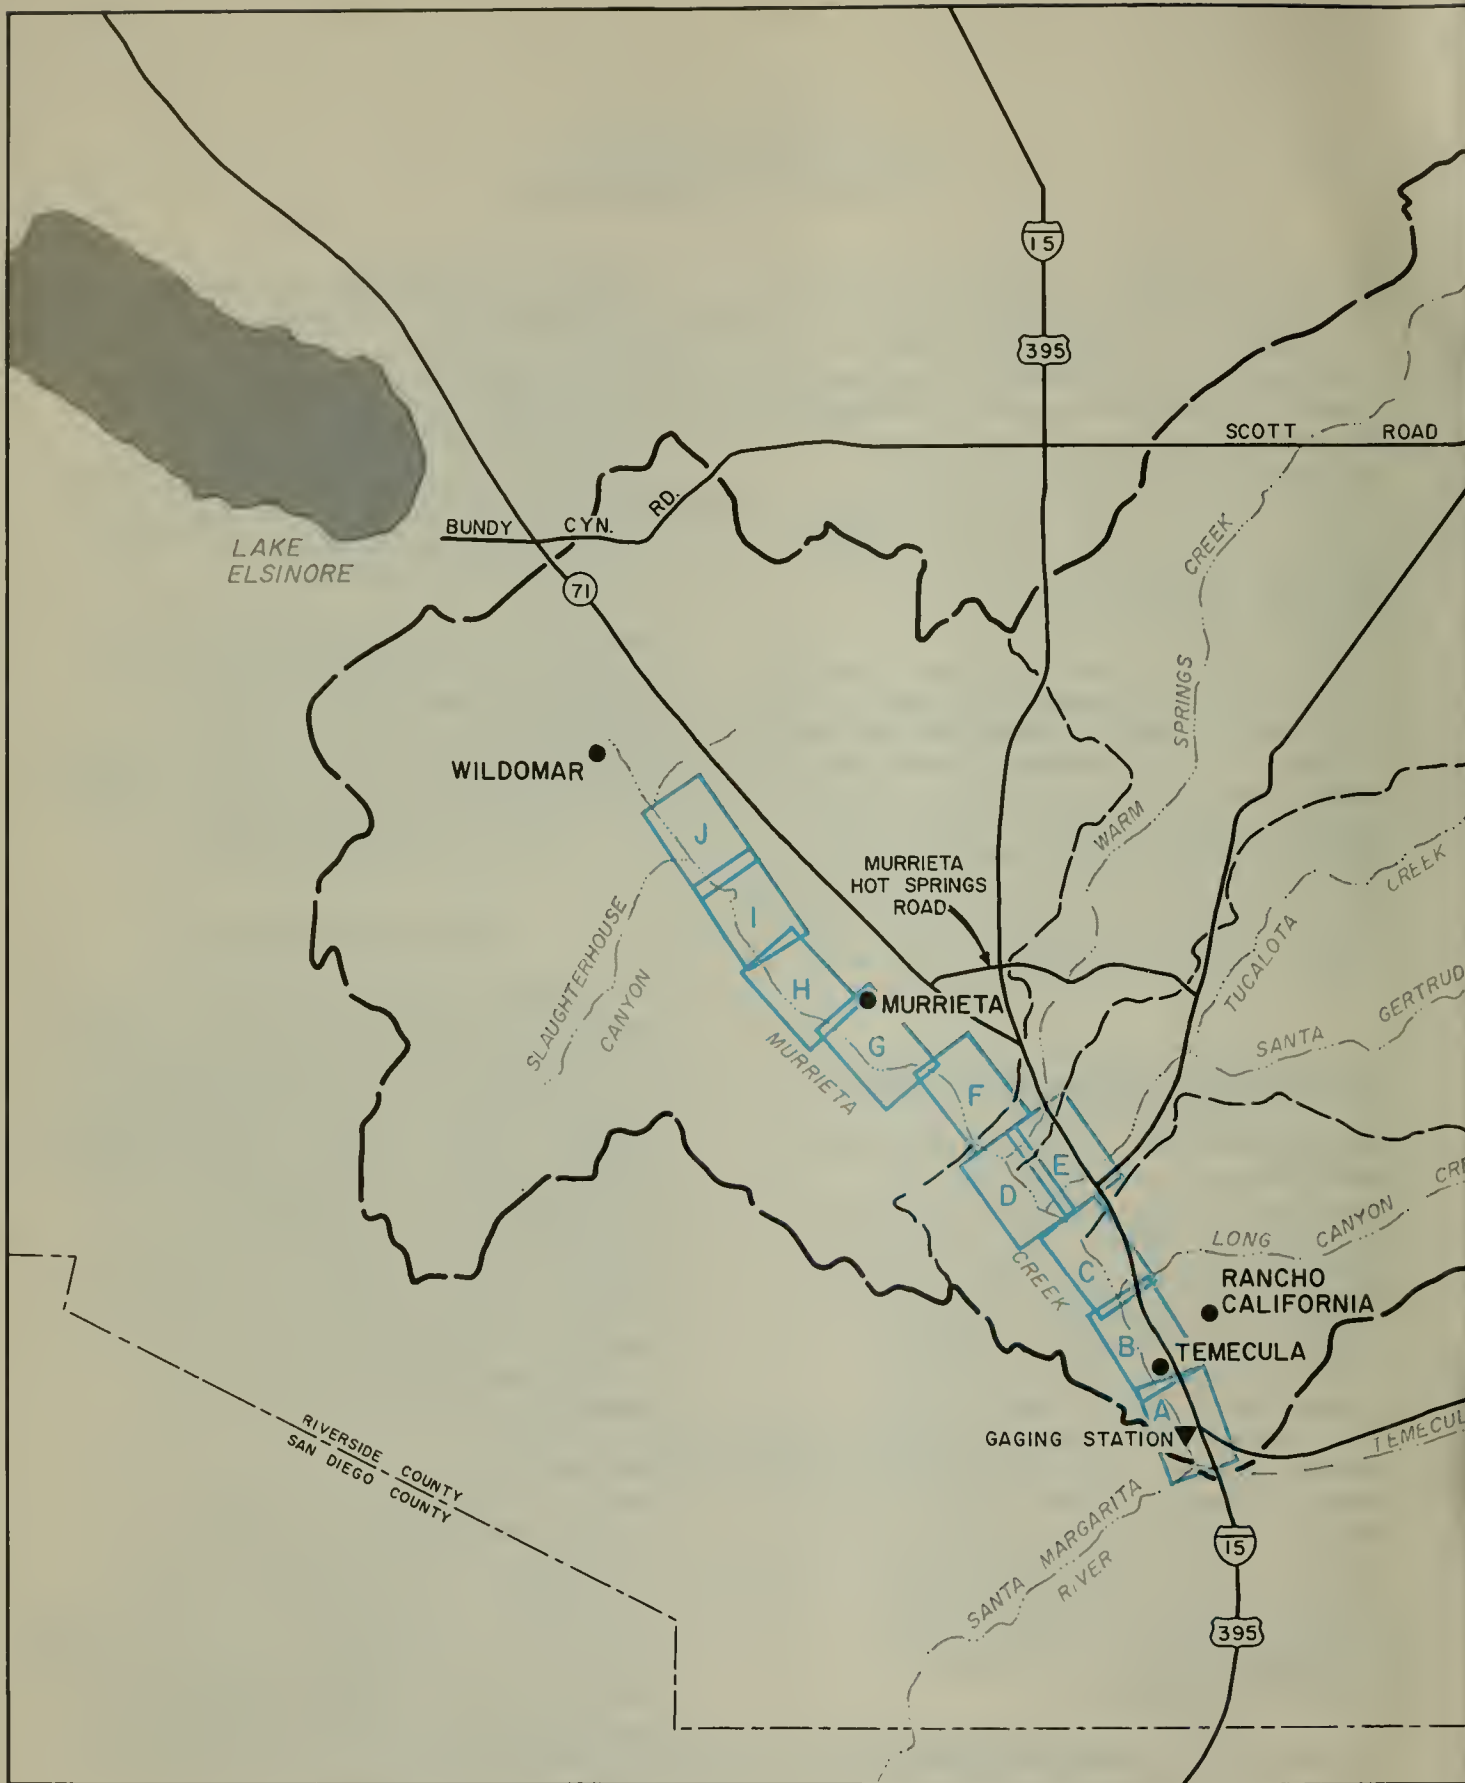
Figure 1—MURRIETA CREEK

WATERSHED AND STUDY AREA

The study area is in western Riverside County about 5 miles south of the City of Elsinore and consists of a portion of the Murrieta Creek watershed. (See Figures 1 and 2.) It covers Murrieta Creek southeastward from Slaughterhouse Canyon to its confluence with Santa Margarita River, a length of approximately 11 miles. It also includes the two major tributaries of Murrieta Creek, Santa Gertrudis Creek and Warm Springs Creek, from their confluence with Murrieta Creek to Escondido Freeway (Interstate 15).

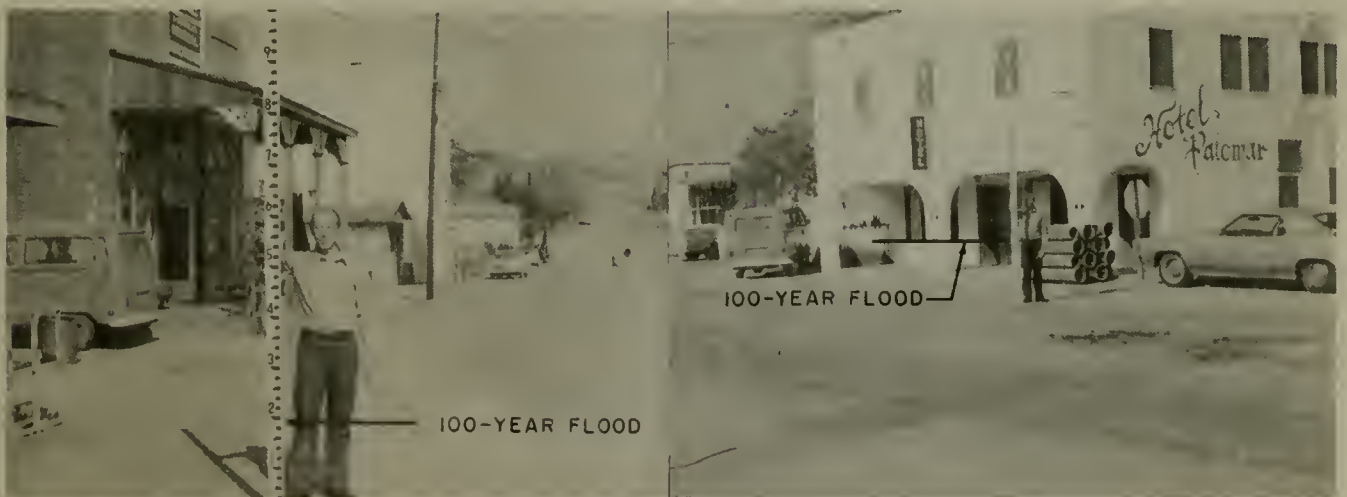
100-YEAR FLOOD HEIGHT IN TEMECULA. Left: On Main Street near Front Street. Right: On Front Street at Fifth Street

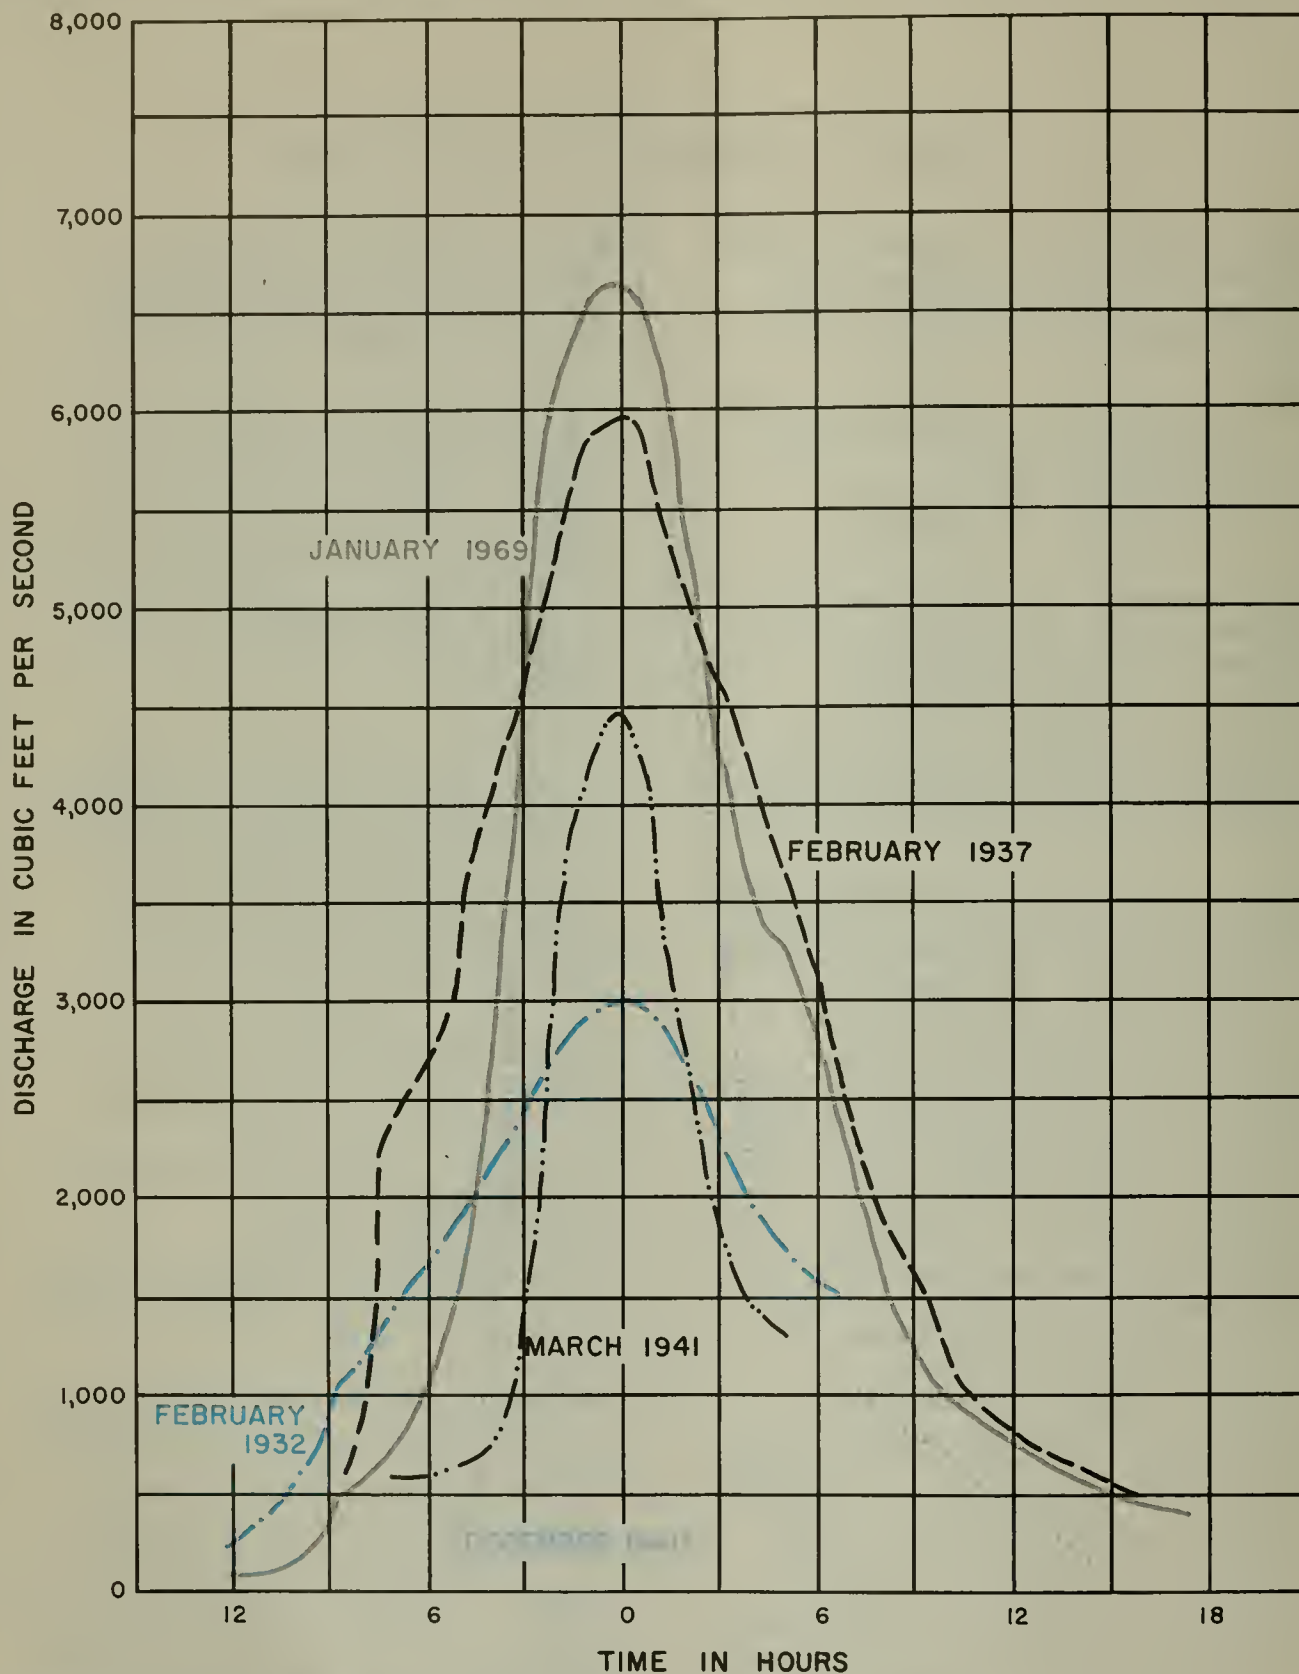
Figure 6—FLOOD HYDROGRAPHS OF RECORD,
"MURRIETA CREEK AT TEMECULA"

For development of a representative hydrograph for the study area, a number of storm hydrographs of Murrieta Creek at Temecula were plotted from records as shown on Figure 6. The hydrograph for the January 25, 1969, storm was selected as the representative hydrograph.

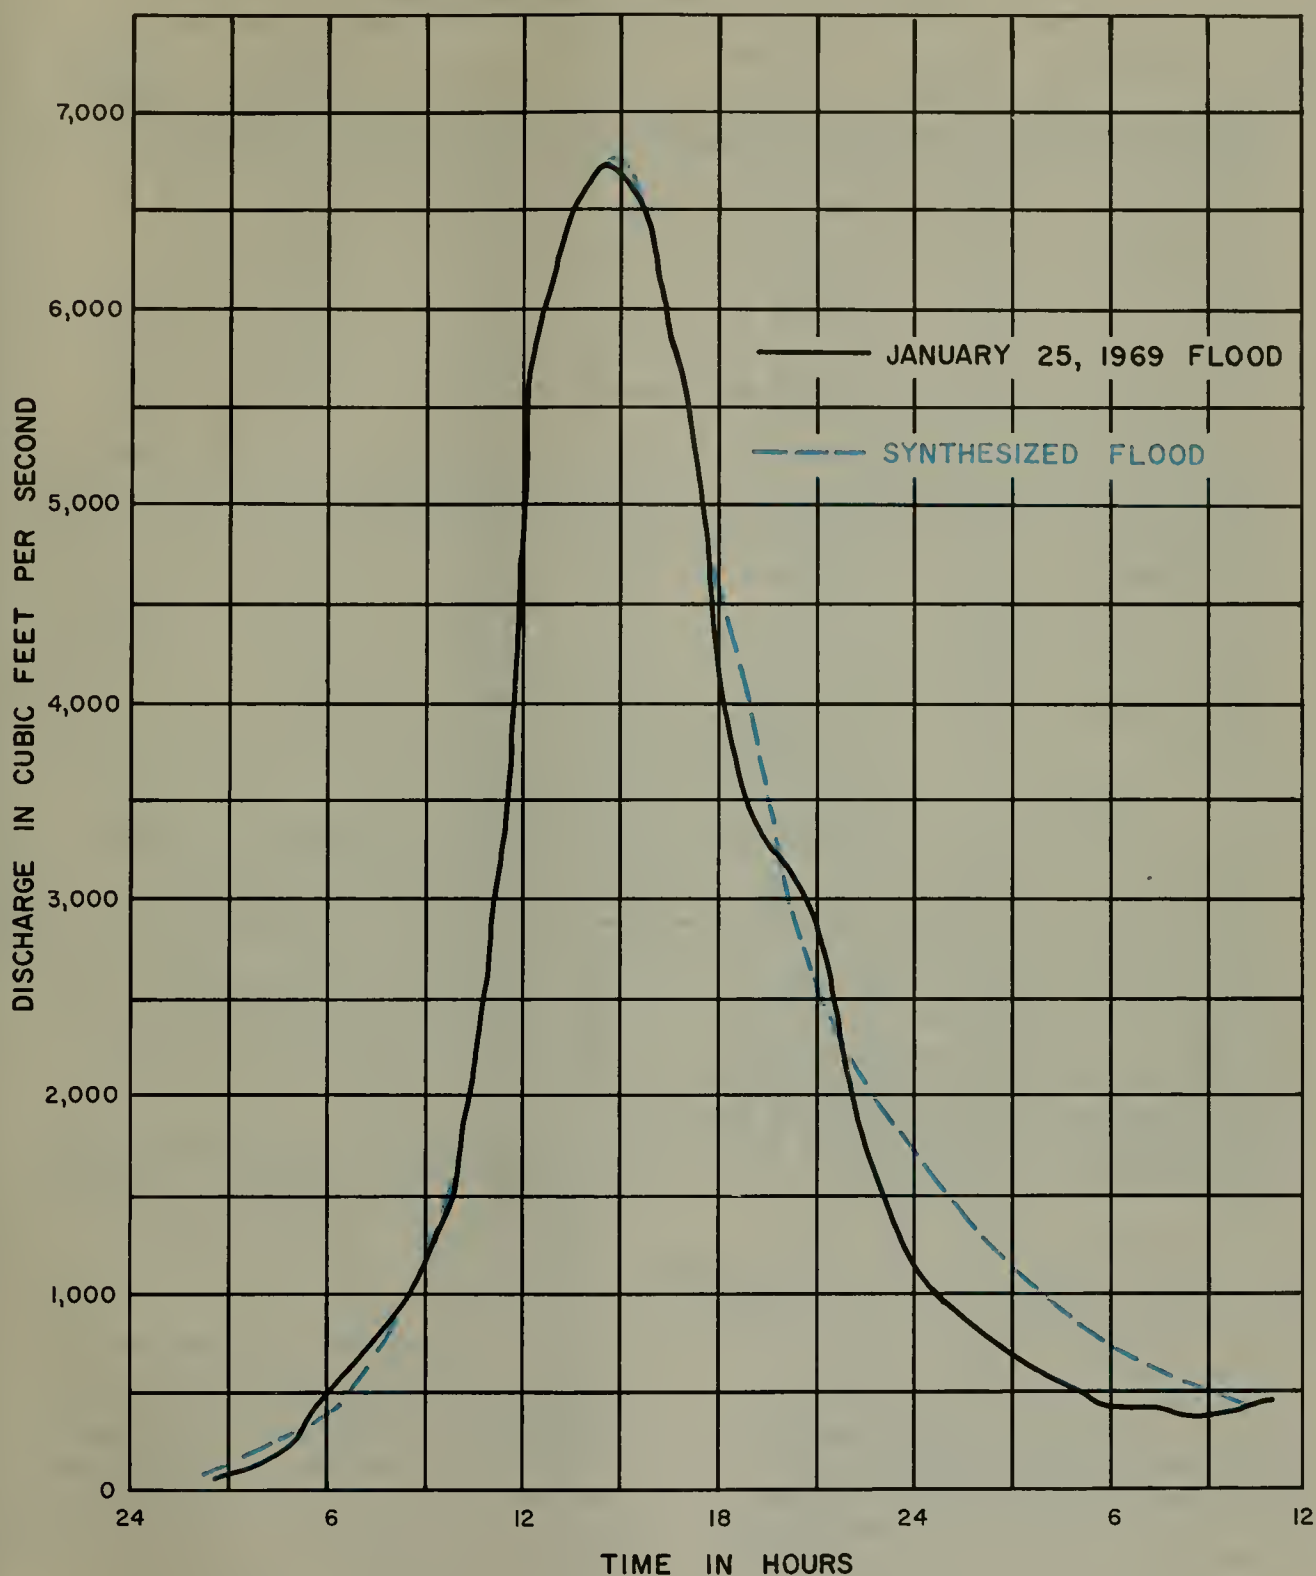
Figure 7— COMPARISON OF SYNTHETIC HYDROGRAPH
WITH JANUARY 1969 FLOOD HYDROGRAPH

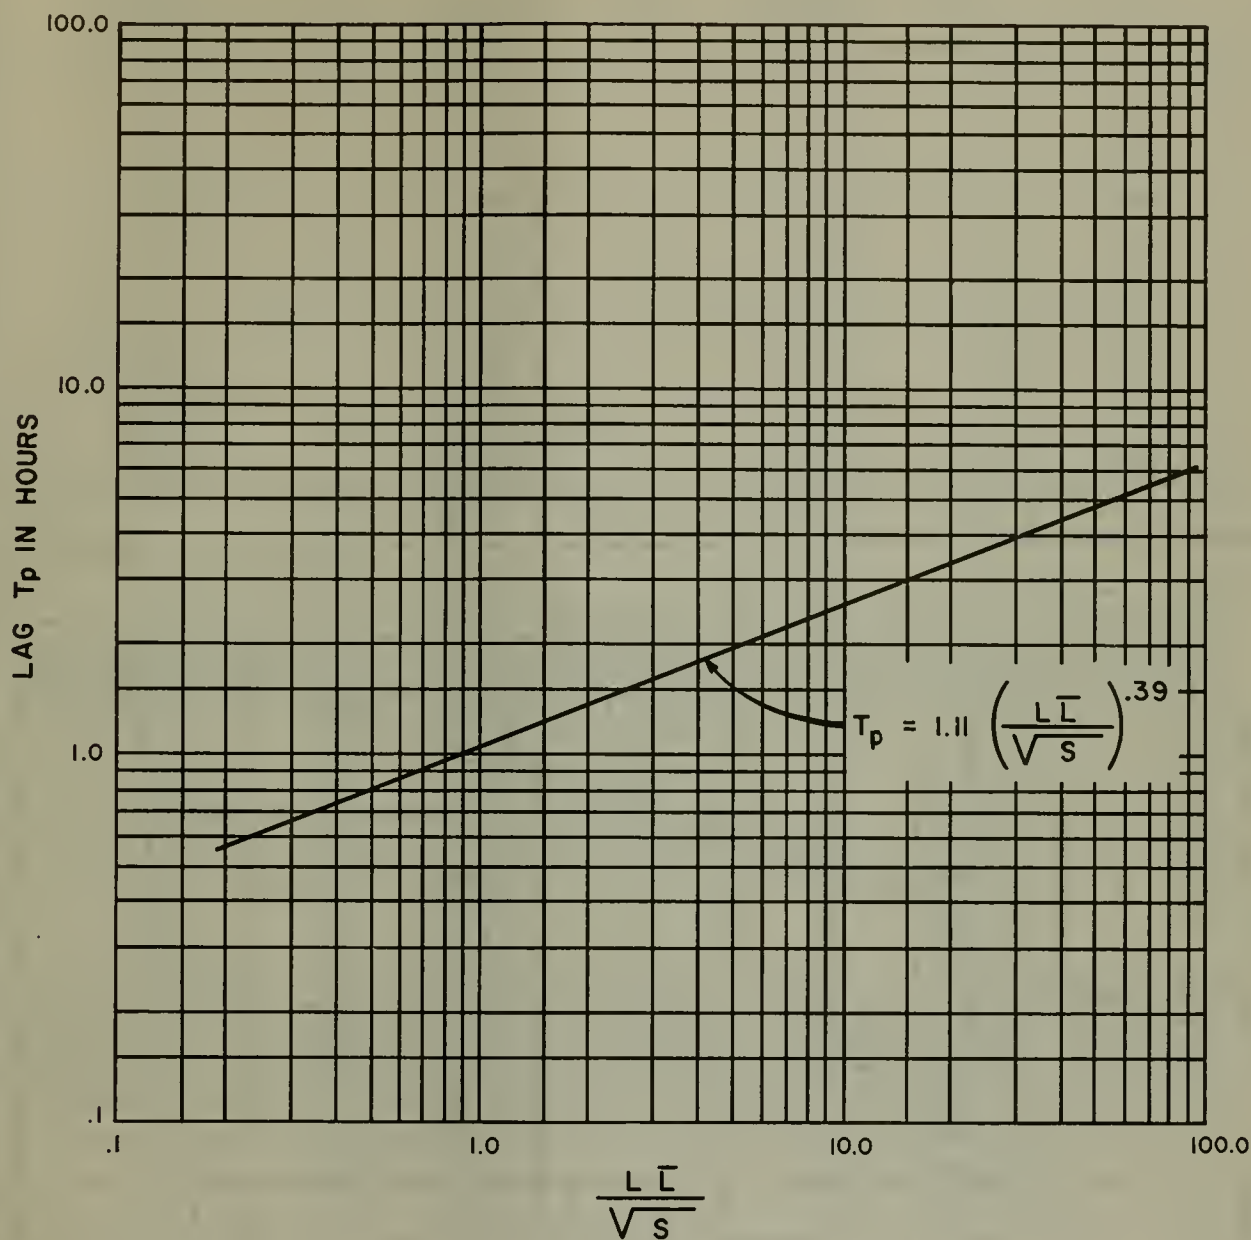
T_p = BASIN LAG IN HOURS

L = BASIN LENGTH

S = BASIN SLOPE

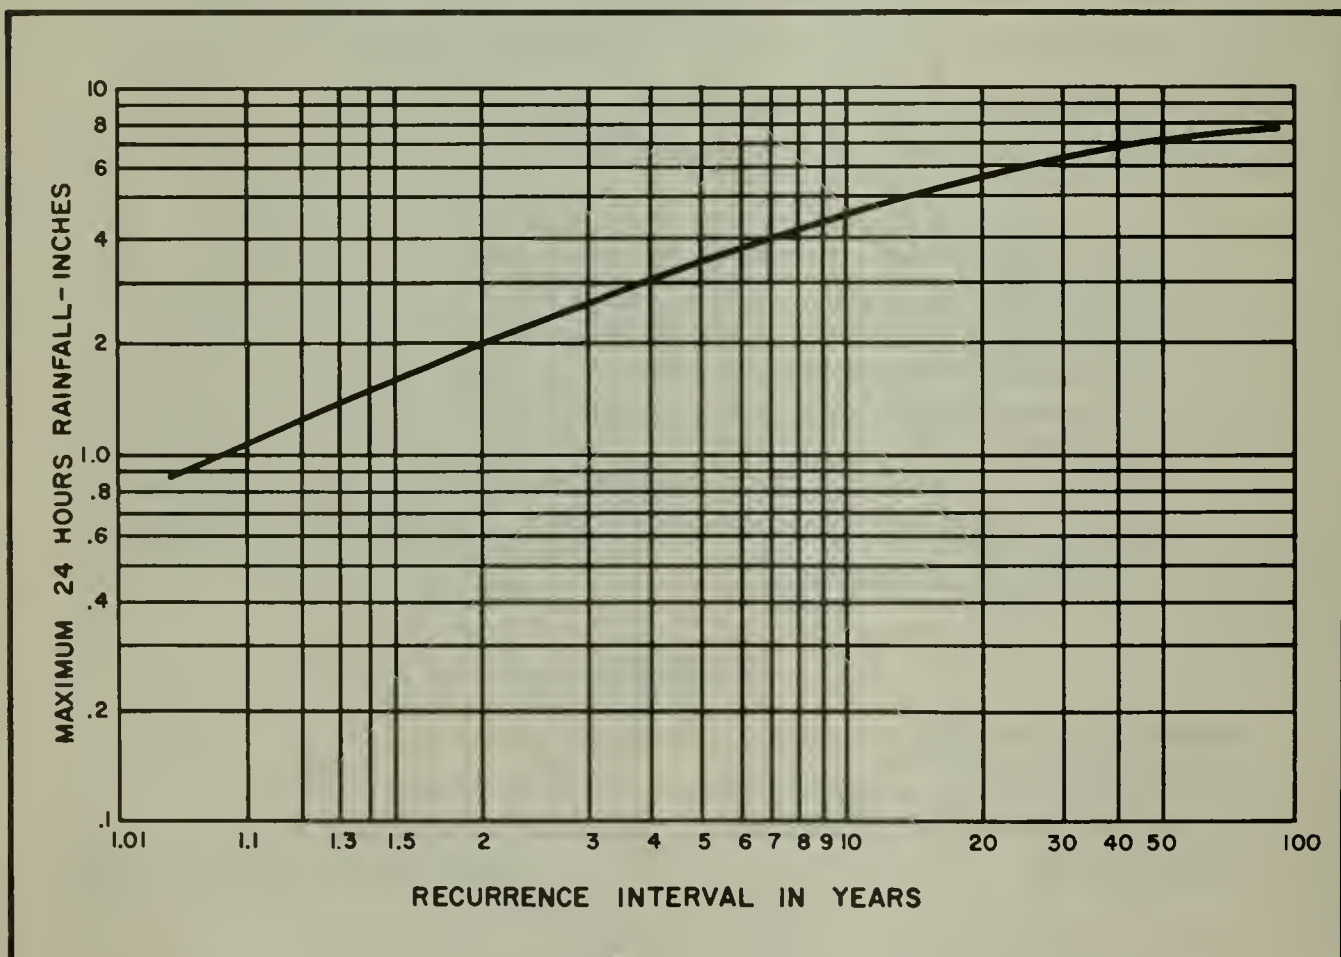
Figure 9 - 24-HOUR RAINFALL FREQUENCY CURVE
AT WILDOMAR STATION (T7S, R4W, SEC.3)

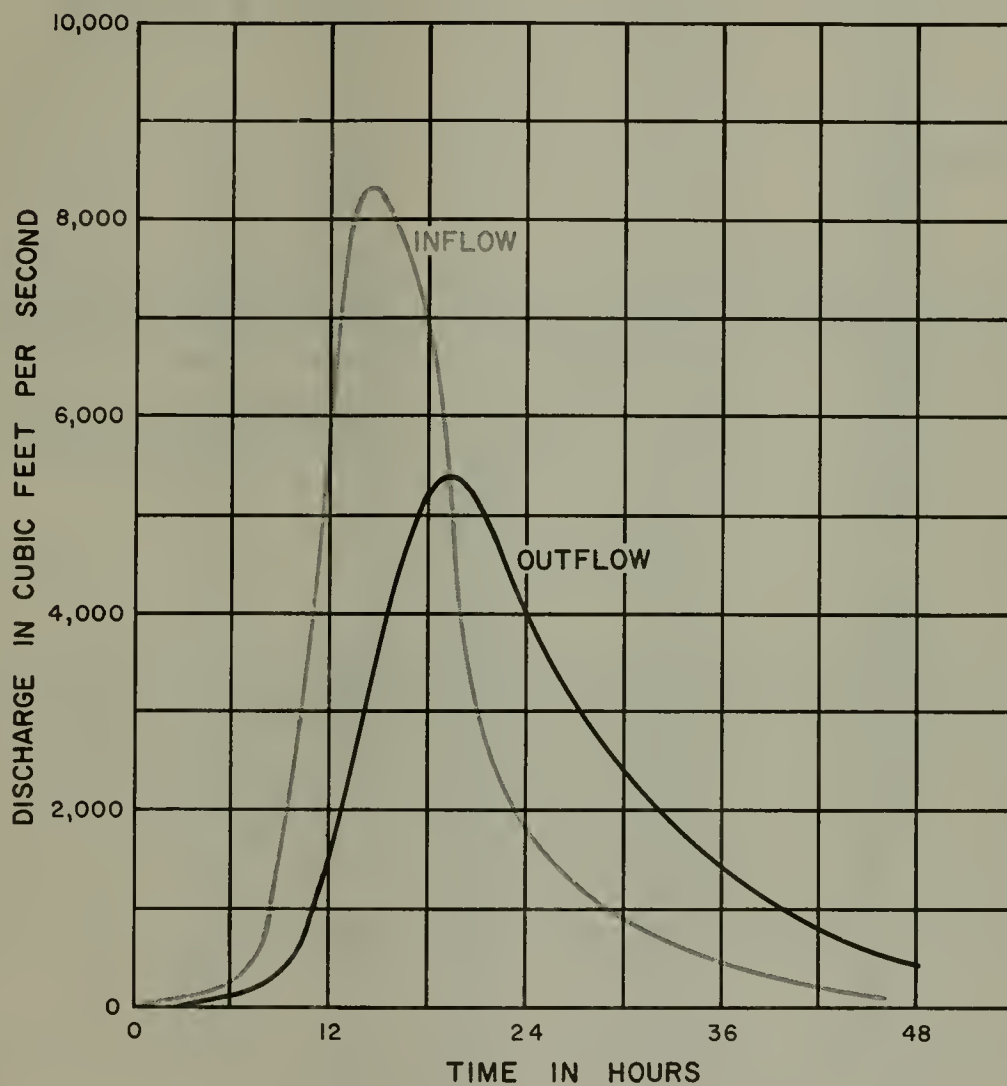
Figure 10—INFLOW-OUTFLOW HYDROGRAPH, LAKE SKINNER,
100-YEAR-FREQUENCY FLOOD (FULL RESERVOIR)

Gertrudis Creek watershed. Although the reservoir does not have any available flood control storage, the outflow is less than the inflow as can be seen on Figure 10, because of surcharge storage above the spillway level.

These hydrographs were then combined to determine the peak discharges at points of major tributaries. The inflow hydrograph to Lake Skinner (Auld Valley Dam) was routed with the outflow hydrograph as shown on Figure 10. Lake Skinner, which serves as a water supply and regulatory reservoir, is assumed to be operated under full reservoir conditions. Therefore, no flood storage capacity was assumed available at the beginning

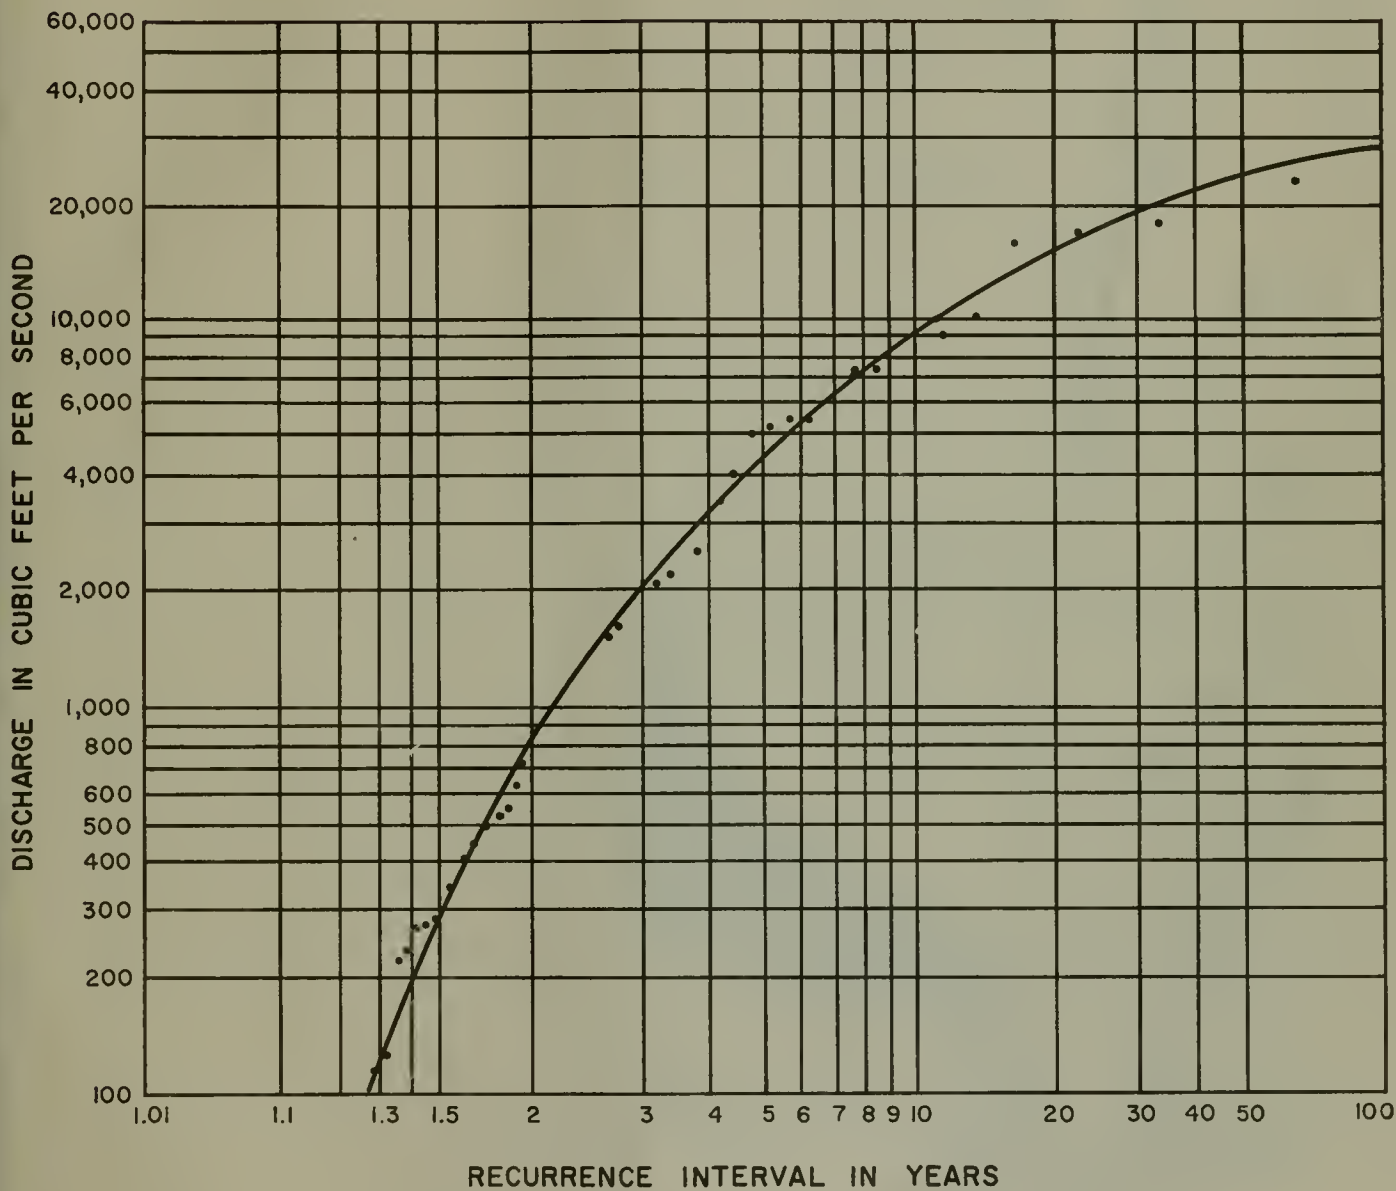
Figure II—DISCHARGE—FREQUENCY CURVE
"MURRIETA CREEK AT TEMECULA"

In order to check the reasonableness of these peak discharges, a discharge frequency curve was developed for gaging station "Murrieta Creek at Temecula" from record (see Table 6). Plot of the curve is shown in Figure 11. Extrapolation of the curve shows a once-in-a-hundred year discharge of about 29,000 cfs which compares favorably with the 30,900 cfs computed for this study and with the District's unpublished study "Hydrology Report for Temecula and Murrieta Creeks and their Tributaries" and the U. S. Corps of Engineers' "Report on the Hydrology of the Santa Margarita River and Tributaries" of March 15 1949.

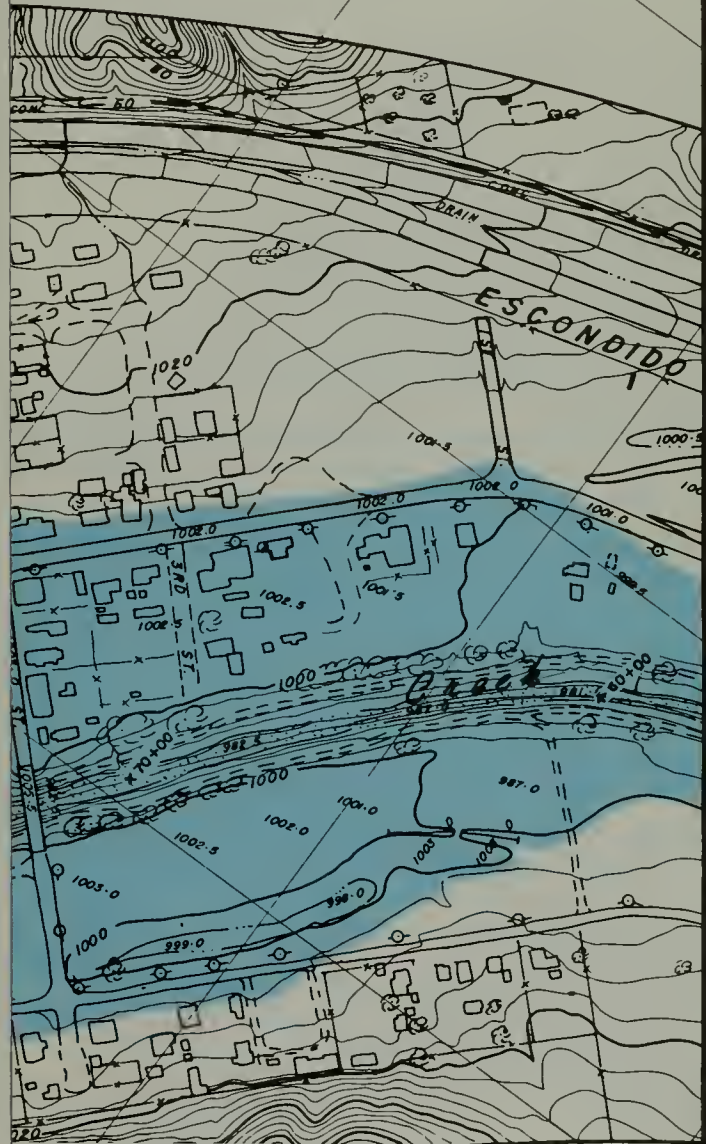
AREAS OF POTENTIAL INUNDATION
REACH B MURRIETA CREEK

The computed water surface elevations were plotted on topographic maps furnished by the District, and the areas of potential inundation were delineated. Plates 1 through 10 show areas subject to flooding along Murrieta Creek and in the community of Temecula, as well as the industrial complex between Main Street and Rancho California Road. Many of the roads would be inundated wholly or in part with some overtopping of the bridge crossings at Main Street and Rancho California Road.

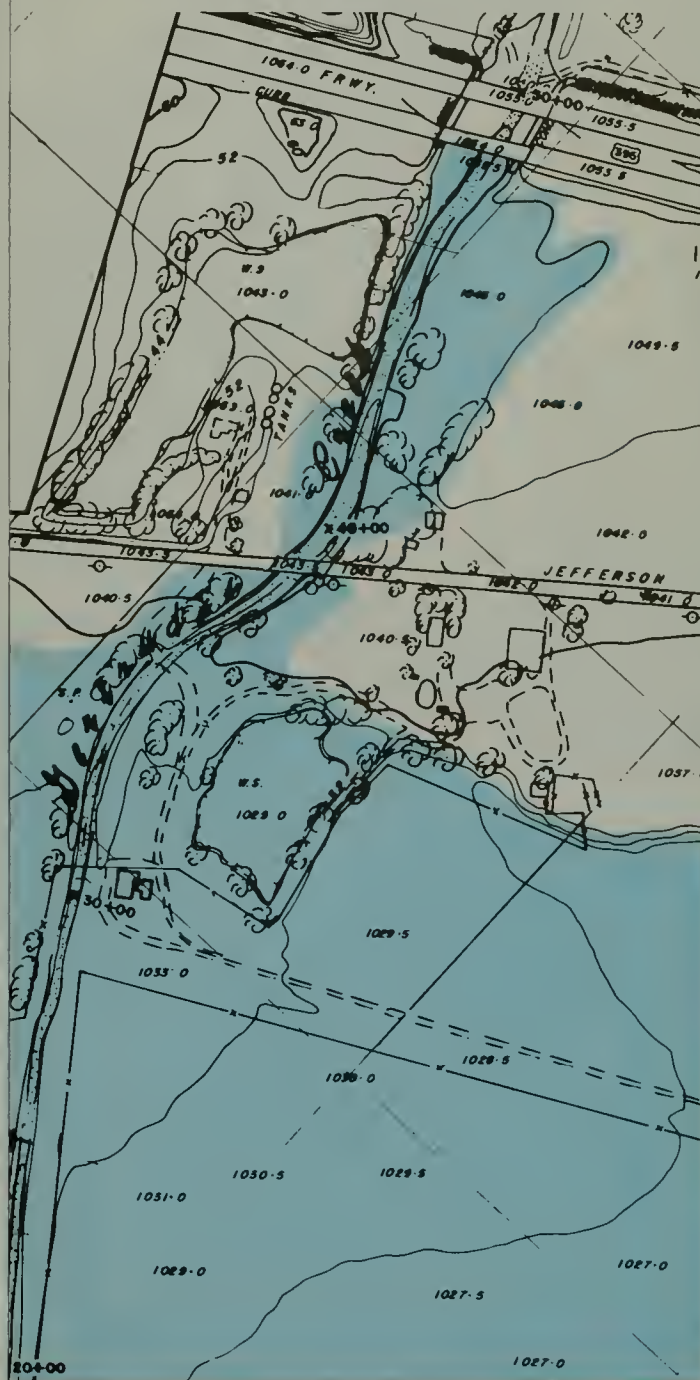
AREAS OF POTENTIAL INUNDATION
REACH E MURRIETA CREEK,
SANTA GERTRUDIS CREEK AND
WARM SPRINGS CREEK

Plates 4 and 5 show areas subject to flooding along Santa Gertrudis Creek and Warm Springs Creek. The areas delineated are based on estimated maximum carrying capacity of these two channels, 1,400 cfs and 1,300 cfs, respectively. In both cases, the capacity is considerably less than the estimated peak discharges. As in Murrieta Creek, if the lower reaches of these two channels were improved to carry the peak discharges, the areas subject to flooding could be reduced substantially.

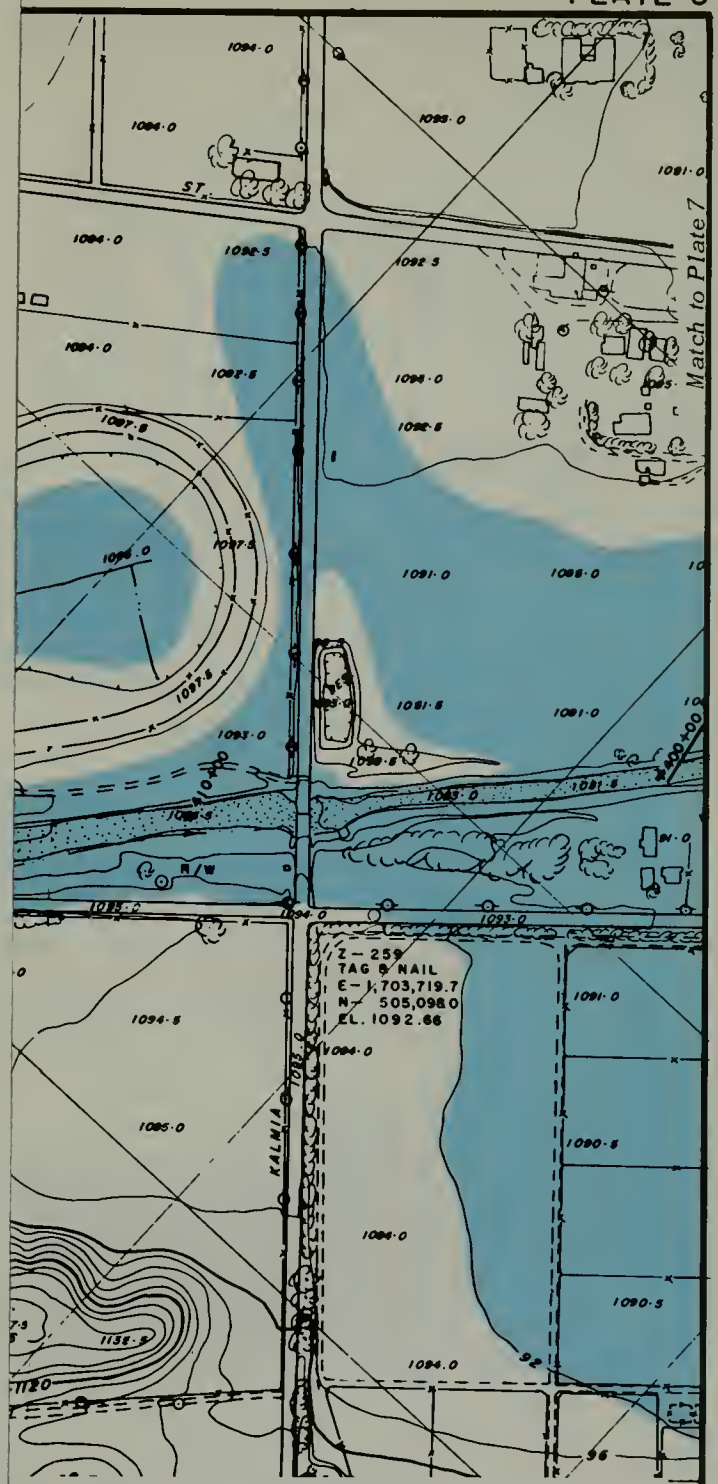
STATE OF CALIFORNIA
THE RESOURCES AGENCY
DEPARTMENT OF WATER RESOURCES
SOUTHERN DISTRICT
FLOOD HAZARD INVESTIGATIONS
AREAS OF POTENTIAL INUNDATION
REACH H MURRIETA CREEK

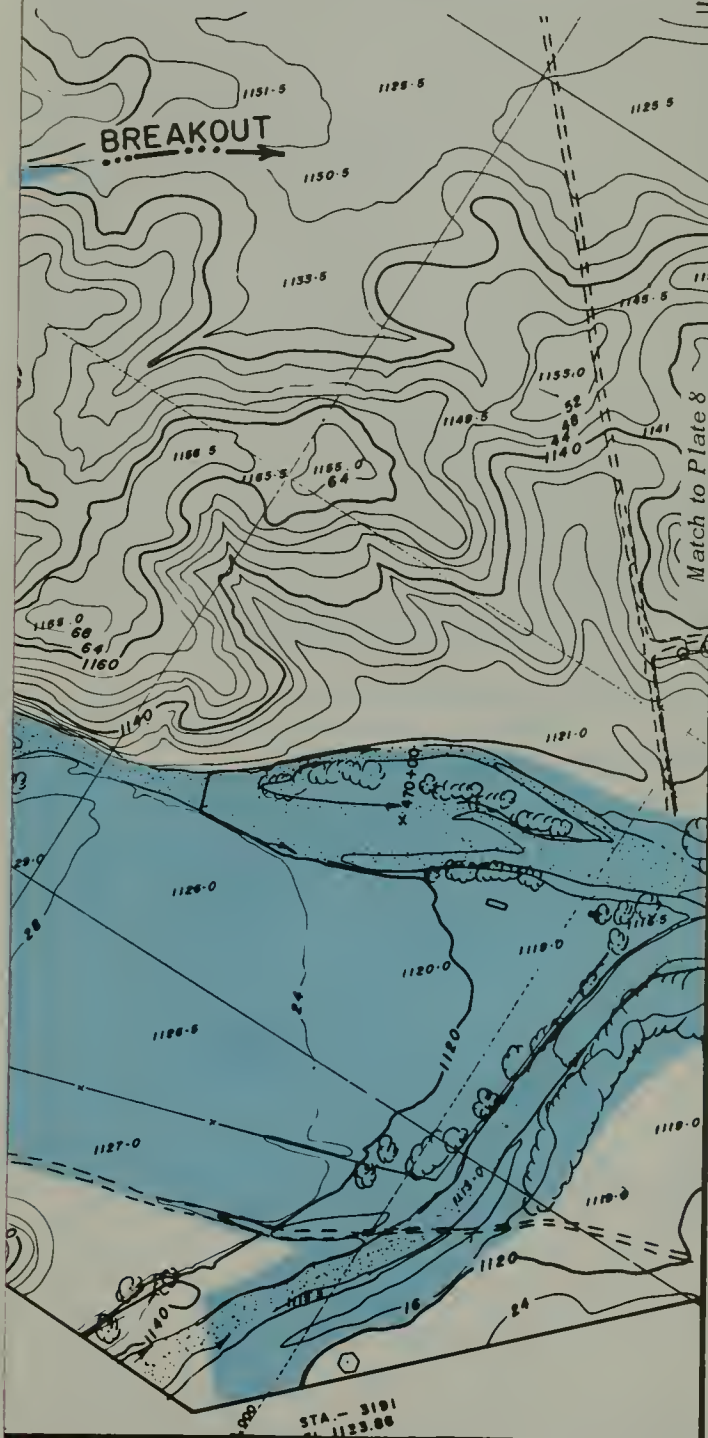
FLOOD HAZARD INVESTIGATIONS
AREAS OF POTENTIAL INUNDATION
REACH I MURRIETA CREEK

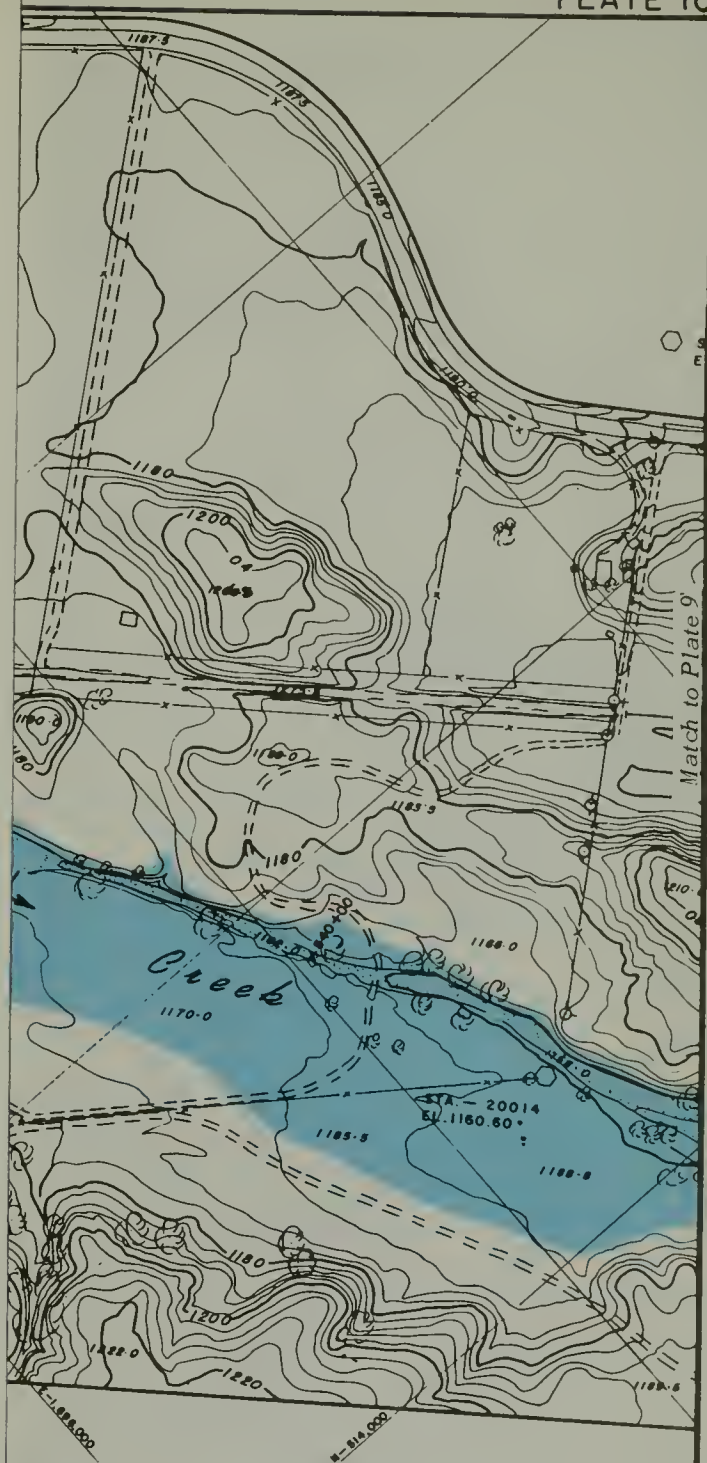
AREAS OF POTENTIAL INUNDATION REACH J MURRIETA CREEK
